Manhole Inspection Summary

Manhole # S130__025MH

Insp Date: **3/24/08 9:05 AM**

Location Address: **424 Font Hill**

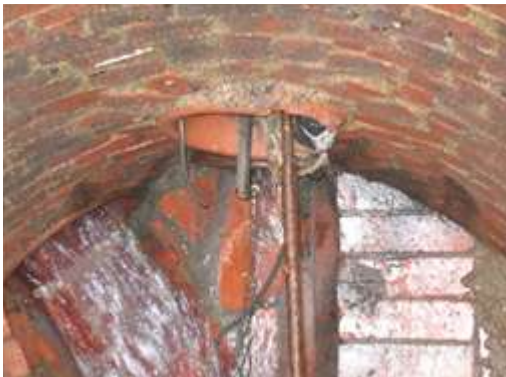
misc

debri in pipe

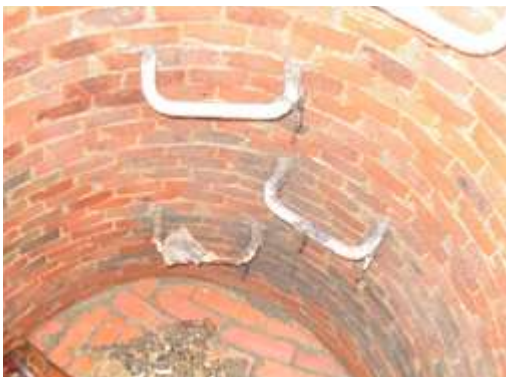
Defect 1

☒ **Evidence Of Surcharge** Depth: **5** (ft.) ☐ Active Surcharge Present

signs of surcharge

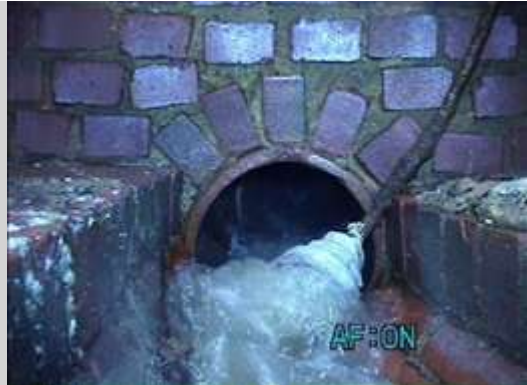
12 O'Clock Outflow

Pipe Height: **10.8** (in.) Rod and Bar (Angled)
Pipe Material: **Clay** ☐ Pipe Lined
Invert Depth: **9.96** (ft.) Flow Characteristics: **Fast**
Deposits: ☐ None ☐ Mud ☐ Sludge ☒ **Debris** ☐ Grease
Silt Depth: **2** (in.) Deposits Extent: **Light**
Infiltration: **Evidence** Pipe Seal Cond: **Unknown**

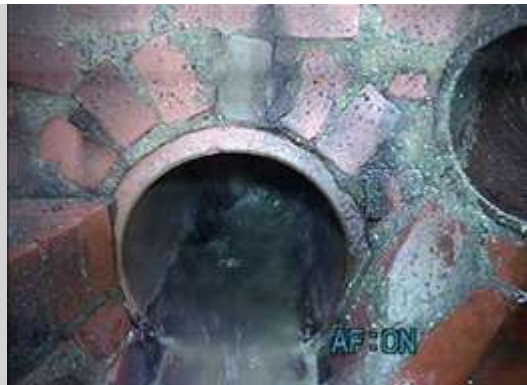
5 O'Clock Inflow

Pipe Height: **10.8** (in.) Rod and Bar (Angled)
Pipe Material: **Clay** ☐ Pipe Lined
Invert Depth: **9.34** (ft.) Flow Characteristics: **Fast**
Deposits: ☒ **None** ☐ Mud ☐ Sludge ☐ Debris ☐ Grease
Silt Depth: **0** (in.) Deposits Extent:
Infiltration: **None** Pipe Seal Cond: **Sound**

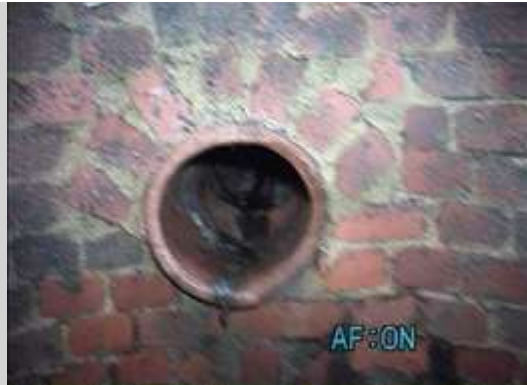
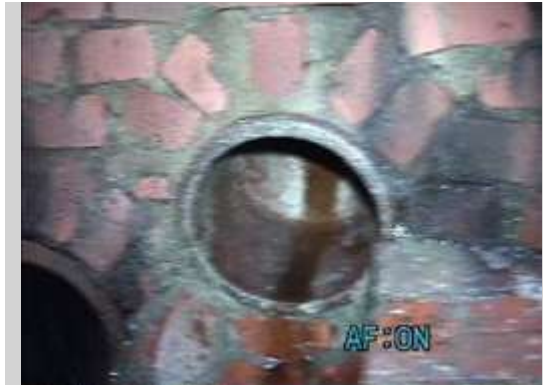
6 O'Clock Inflow

Drop: Inside	Rod and Bar
Angled: Yes	Reading: 7.88 (ft.)
	Inv Depth: 8.88 (ft.)
Drop Condition: Open
